Stent Distortion Occurs With Side-Branch Dilatation with all Stents

Side-branch distortion is repaired by main vessel post-dilatation or better by “kissing” balloons

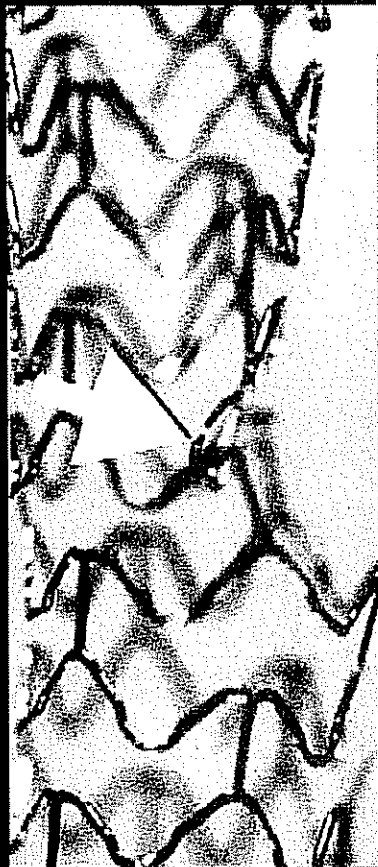
**Distortion after
3mm
side branch
dilatation**

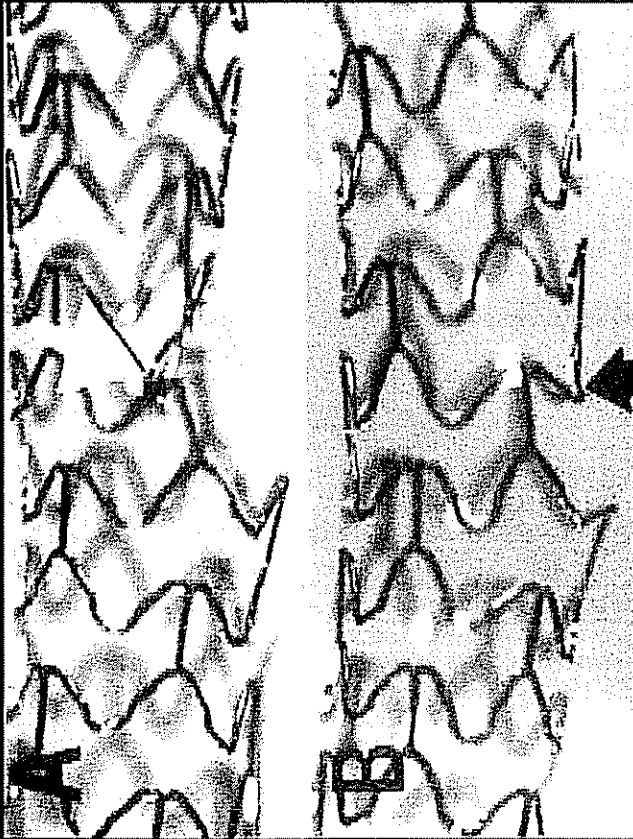
Stent Distortion Repaired by Main Branch Redilatation with some loss of Side- Branch Size

**3mm side-branch
dilatation**

**3.5mm main
branch dilatation**

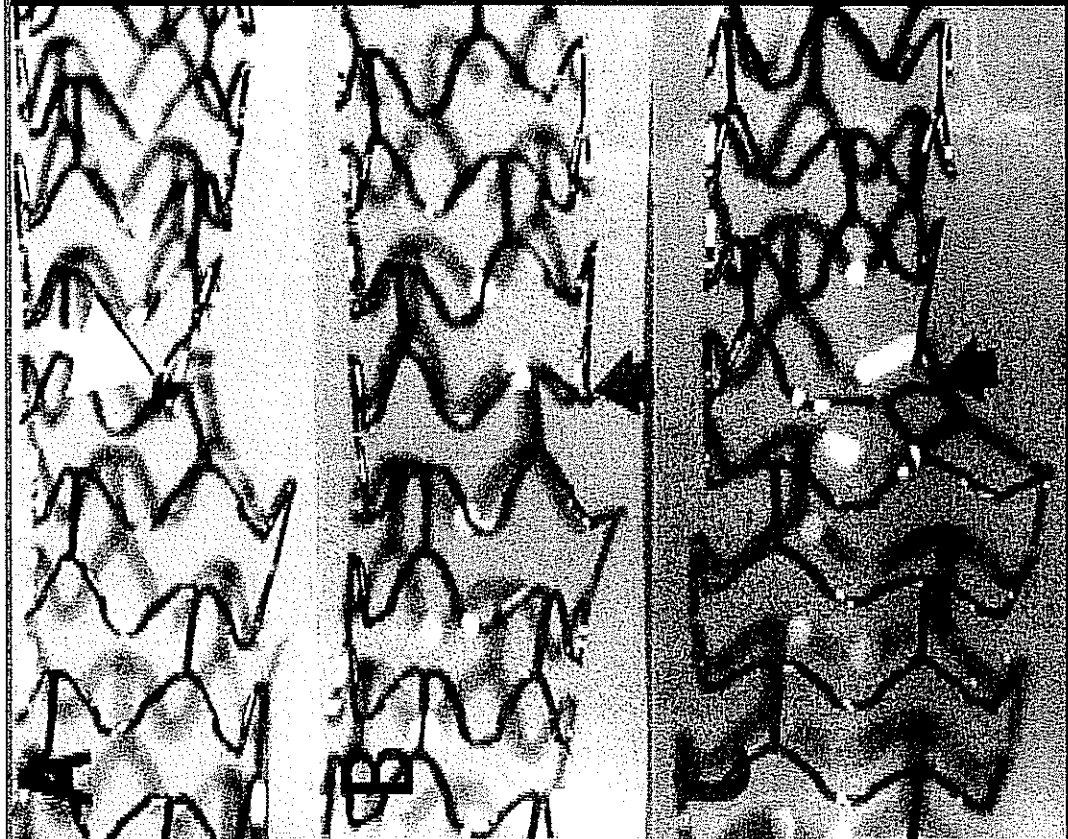
3mm side-branch
dilatation

3.5mm main
branch dilatation

Kissing balloons

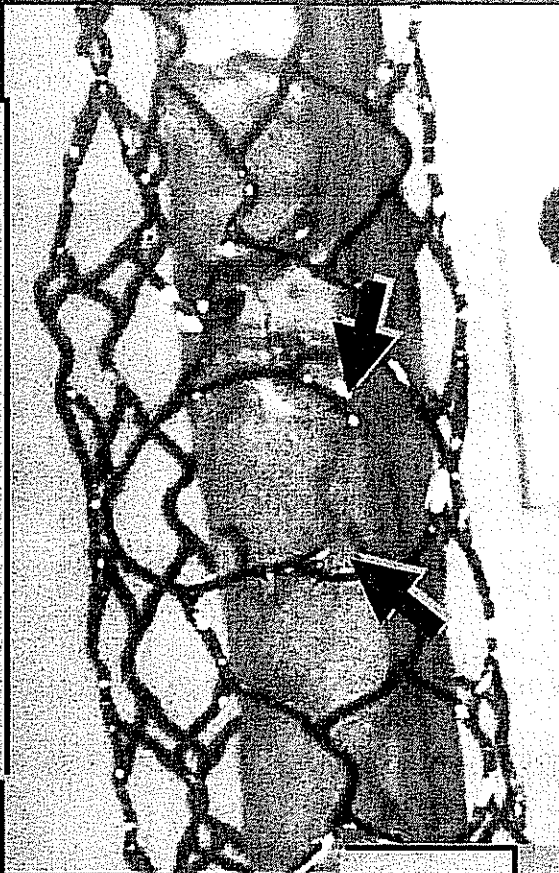
Older ring design (not seen
with new ring designs)

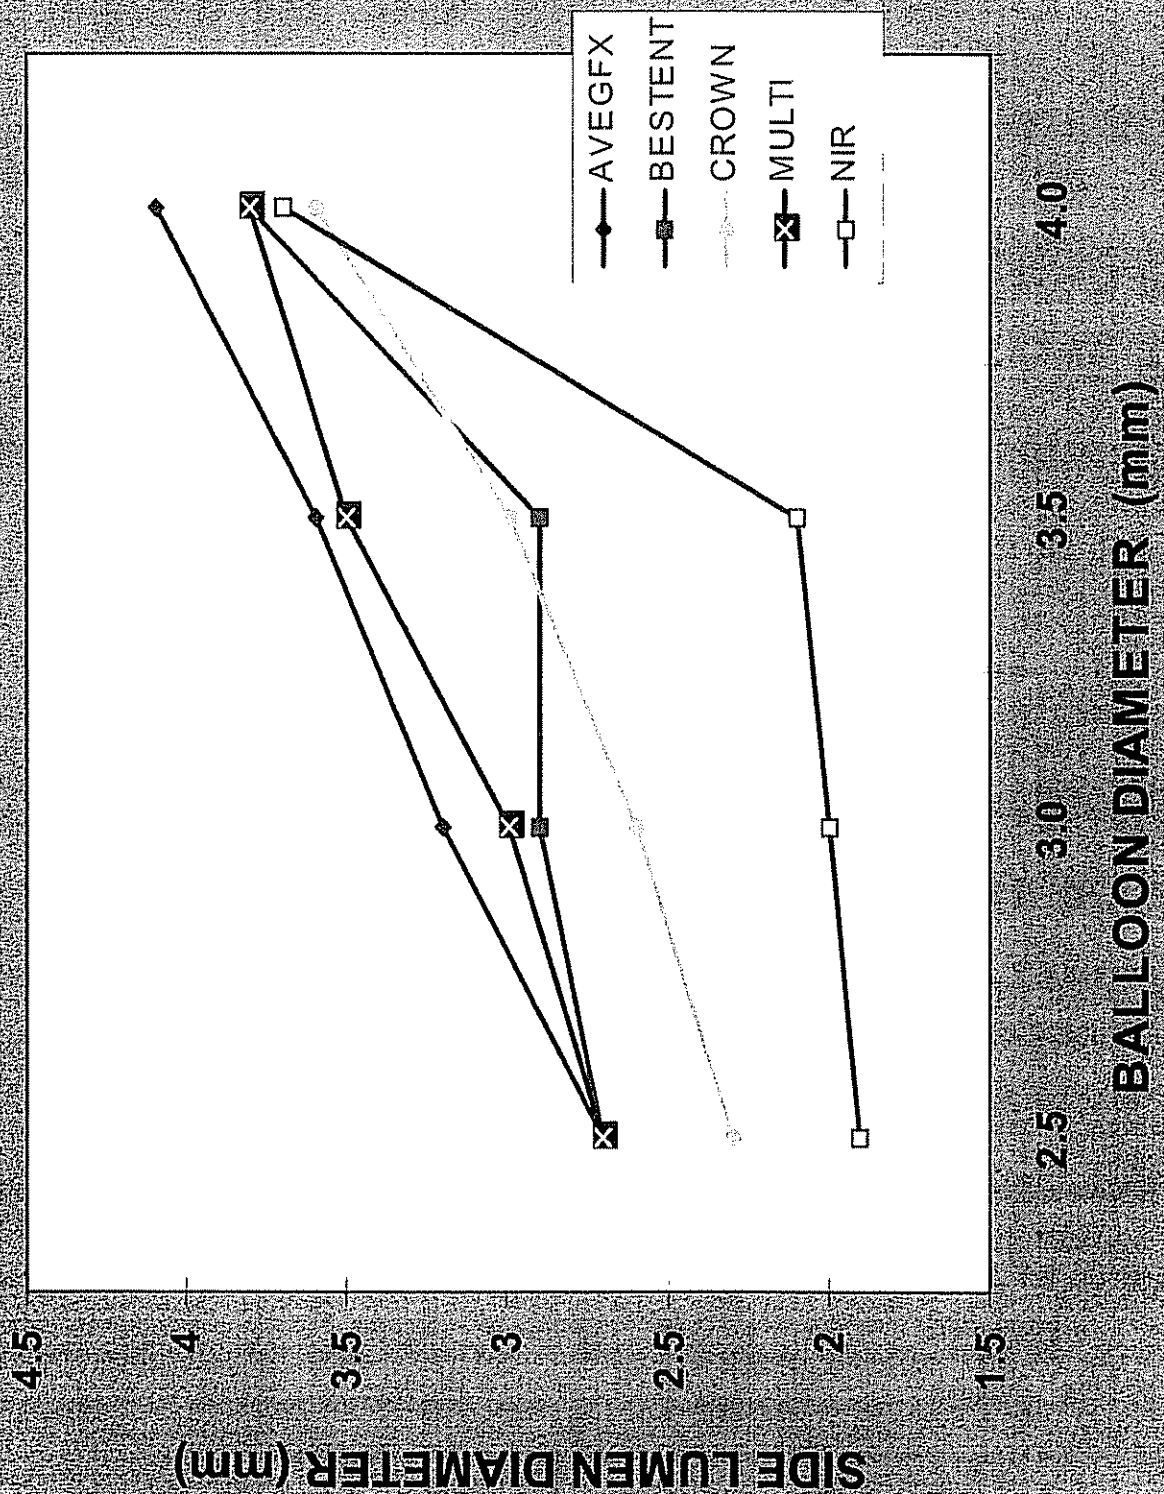
SIDE LUMEN DIAMETER FOR DIFFERENT BALLOON SIZES
